# Two Strikes, You're Out: Safety Means Success on This SPF Roof

By Stephanie Marie Chizik

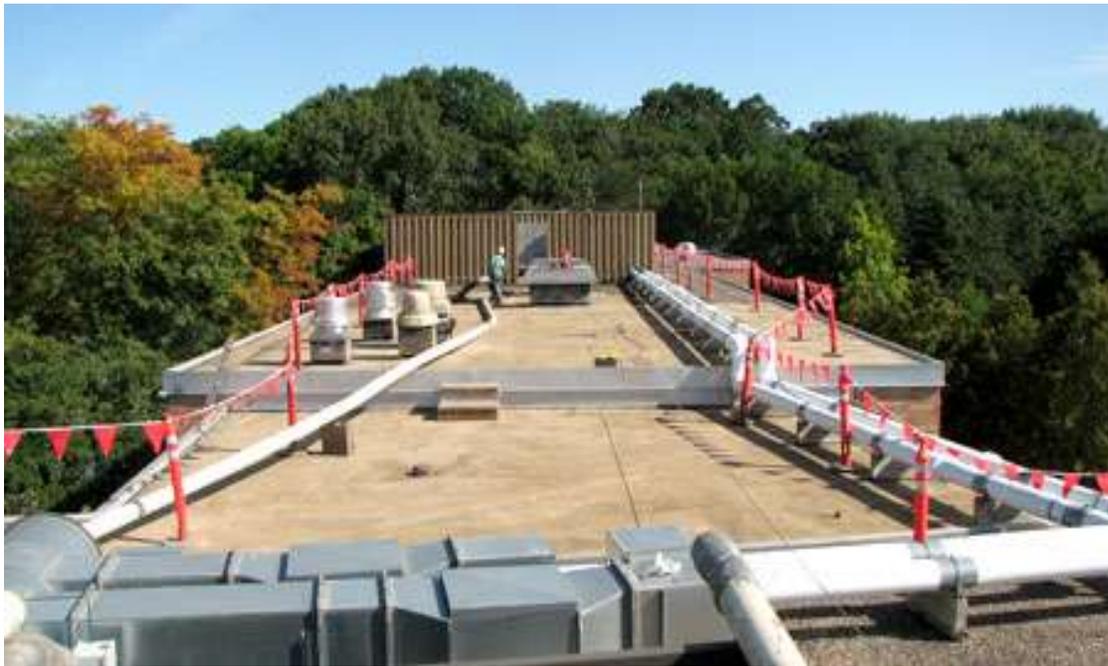
The first parameter the Kohls crew had to tackle was the roof's surface. With 9,600 square feet to cover, safety on (and in) the research and development rooftop was paramount.

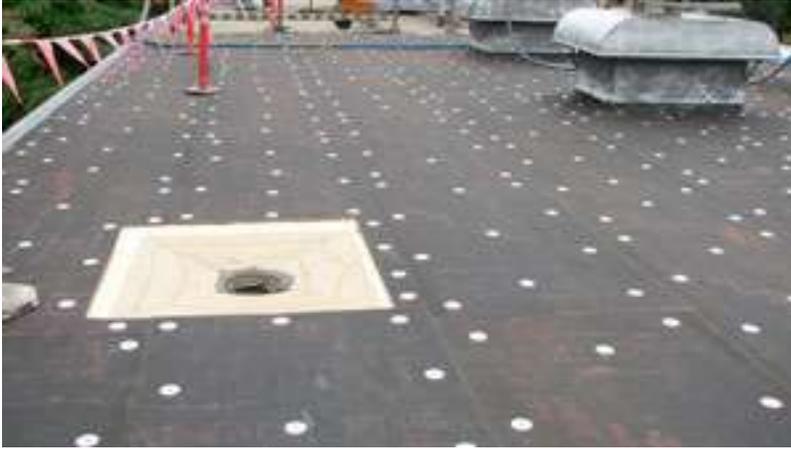
To start, the Kohls team needed to mark off the roof's parameter — several sections three stories high. Safety barriers were set up all around the edge of the building. Unfortunately, because the building was open for business during renovations, the SPF crew also had to work around the Cargill employees — and their cars.

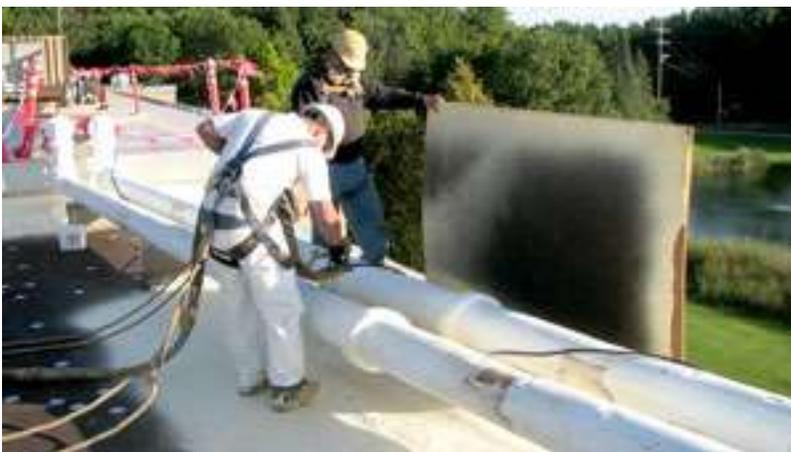
However, the crew could not escape their first item to attack: the old ballasted EPDM system. After removing the old EPDM system, the crew found a rigid board with aluminum facing on it. Because about 80 percent of this layer was dry, they merely had to remove the wet parts and replace them with one-and-a-half-inch iso board. The Kohls crew attached the new recovery board over the insulation with three-inch plates and metal fasteners, which ranged in size depending on the depth of the

corrugation being reboarded. If the rooftop crews got too close to the conduit beneath the ceiling of the third story, Pat Kohls alerted them via walkie-talkie from the third floor to change the screw size.

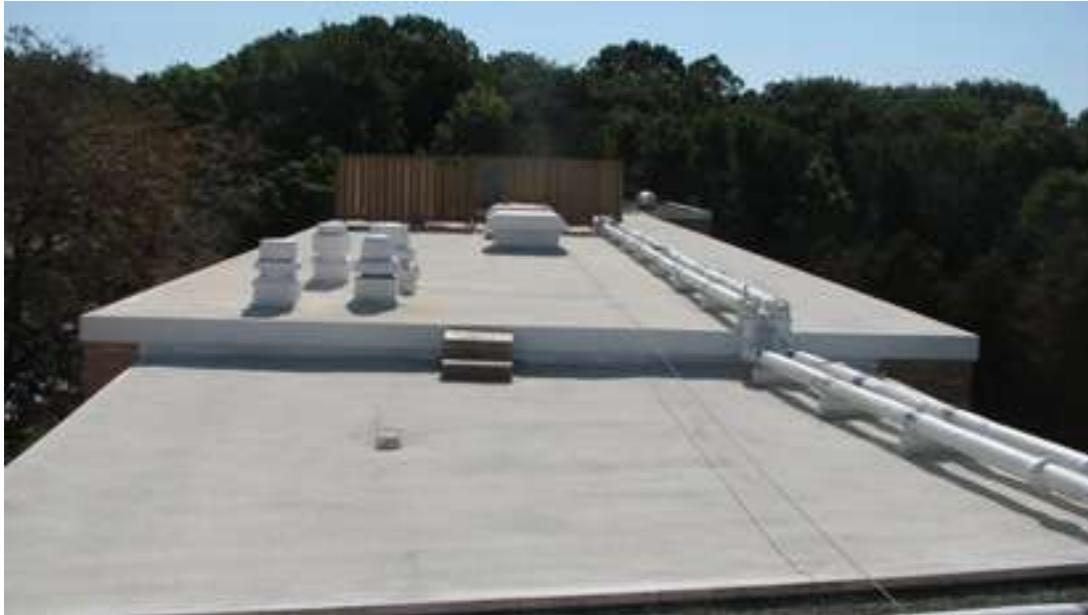
Once the surface had been completely recovered, the team needed to prep for the foam. They used Stihl backpack blowers to remove any debris and to dry the substrate. Because there were Cargill employees

working inside the building during the day (and products were being researched), Cargill required that the facility's HVAC system remain operational throughout the project. This meant they also had to hook up a hose to the air conditioning unit on one of the smaller sections of the rooftop to catch condensation outflow.

When they were finally able to spray, the crew tied off to the roof and pulled the foam and coatings' hoses up top with a rope. They sprayed BASF Polyurethane Foam Enterprises (PFE) 348 2.8-pound foam to help address the building's limits. To achieve a positive flow and drainage on the rooftop, additional foam — in place of scuppers — was added. Because drains were also available minimally, the crew used foam to direct the runoff. They used two inches of the BASF PFE's closed-cell foam to do this, as well as a Gusmer H20/35 and H20/35 Pro Proportioners and 300 feet of hose. To spray under the pipes and on detail work, the crew used FoamCat and Gusmer D guns.

The Kohls crew let the foam cure for a few hours before returning to the first roof section that was foamed. They then applied Conkilyn's benchmark basecoat at 1.9 gallons per square foot with a Graco airless coating gun and 645 tip. This basecoat was allowed to cure for 24 hours before returning with the topcoat. The second layer was a topcoat. The final layer of the topcoat received white SESCO granules to give durability to the roof. These final two layers were applied at 1 gallon per square foot with the same equipment used on the basecoat. All in all, the finished system would give the roof a 15-year warranty.
